Comparison of damage to live vs. euthanized Atlantic salmon *Salmo salar* smolts from passage through an Archimedean screw turbine

R. Brackley*†, M. C. Lucas‡, R. Thomas§, C. E. Adams*
and C. W. Bean*

Final accepted version (Feb 2018) of MS for publication in *Journal of Fish Biology*

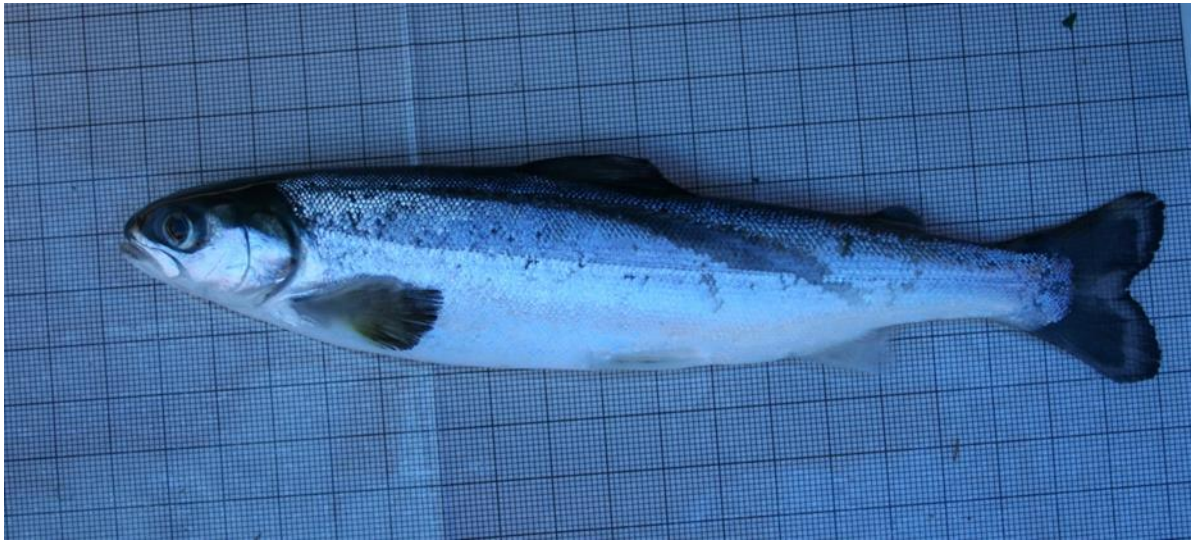
333 FIG 2. The distinctive curved longitudinal stripe of scale loss that was observed in euthanized
334 smolts that had passed through the Archimedean screw turbine. This distinctive pattern was
335 not seen in equivalently handled non-turbine-passed smolts, nor in live turbine-passed, and
336 live non-turbine-passed smolts.

The distinctive patterning of descaling observed in seven of the euthanized treatment fish is consistent with that expected from abrasion by the outer edge of the turbine blade, if a fish was to lodge against the gap between the trough and the turbine blade, once within the turbine. It is proposed that the euthanized fish were drawn towards this gap by water flowing from upper to lower turbine compartments under the differential head. This distinctive pattern of damage was not observed in any of the much larger sample of live turbine-passed fish,
